## **5.0            EXISTING CONDITIONS**

### **5.1            INTRODUCTION**

## 5.4 CASTRO ADOBE / STRUCTURE

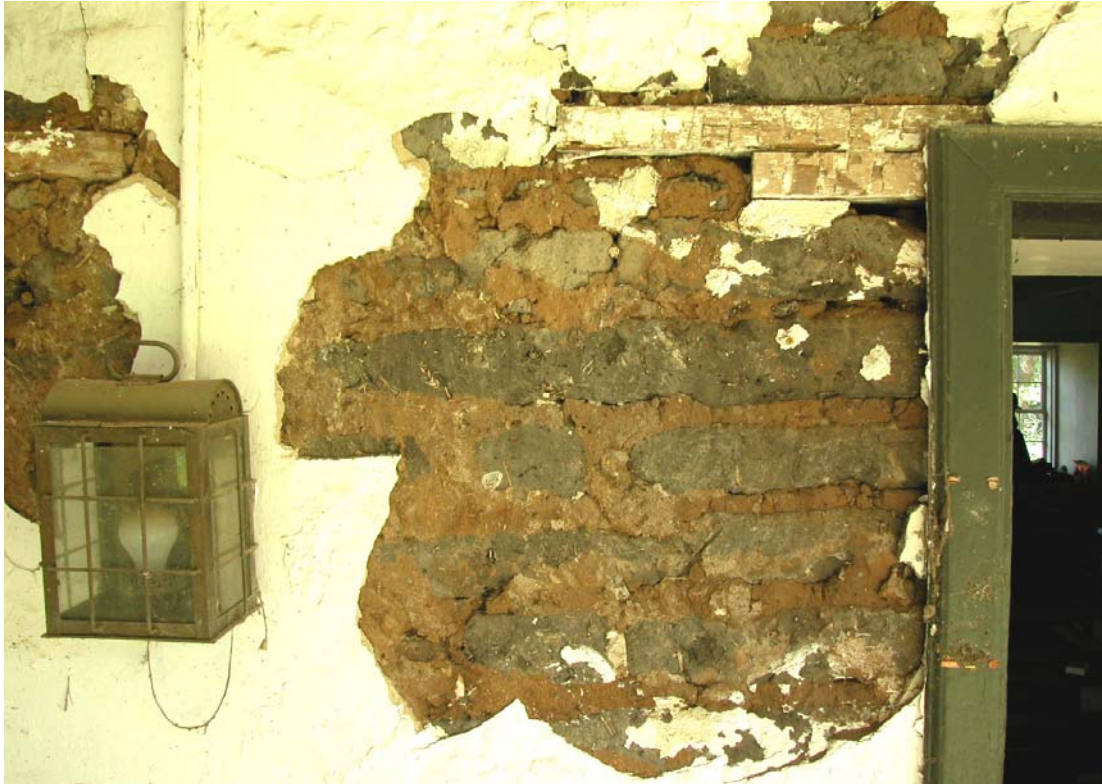
The walls are constructed of 28"x14"x4" adobes and mud mortar. The adobes are dark gray and have higher clay content than the tan mortar. The contrast of the two materials is quite dramatic. The color of the adobes is classified as dark grayish brown (10 YR, 3.5/2) by the Munsell color system. The mud mortar is classified as dark yellowish brown (7.5 YR, 4/4). Figure 5.4 shows a typical exterior surface of exposed adobes.

**Figure 5.5:** A section of adobe masonry exposed on the east exterior wall. Digital photograph by A. Crosby, April 2003.

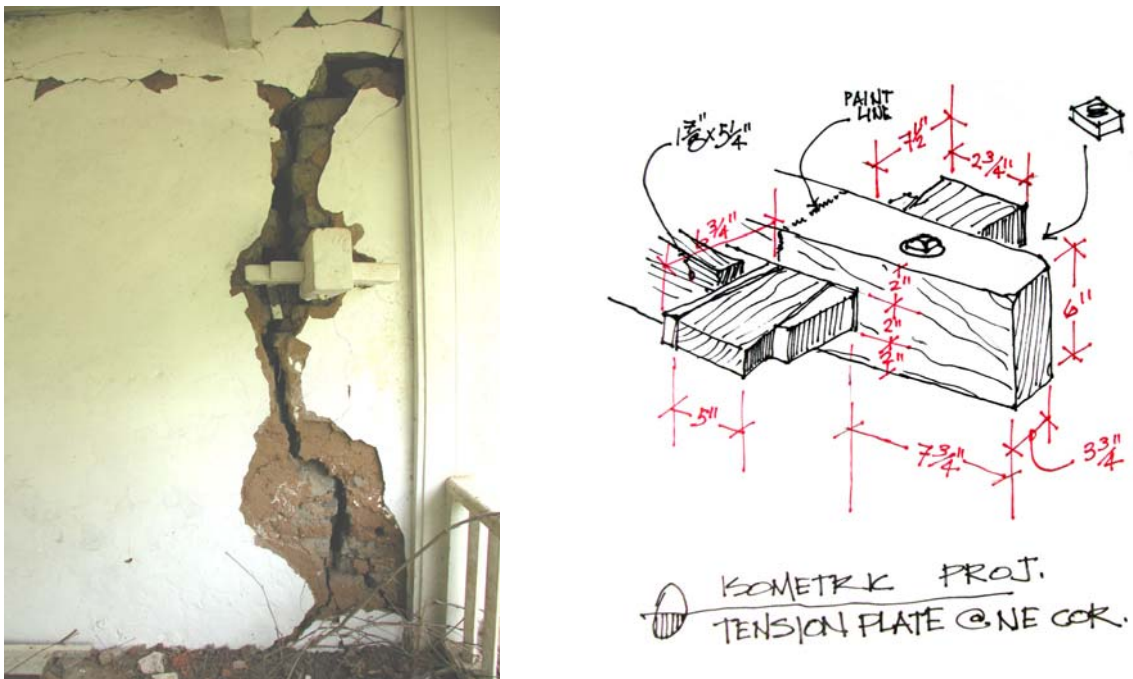
The timber wall tie was set into the north wall and extended through the east and west walls. A set of wood wedges on either end of the timber provided the compression bearing plate of the system. A steel bolt set behind the wood wedges kept the main timber from splitting. Figure 5.6 is a photograph and a sketch of the system. The west end on the exterior surface of the west wall is similar in detail.

**Figure 5.6:** Photograph and an Isometric drawing of the timber tension wall tie. This shows the east wall end of the system. Sketch and digital photograph by A. Crosby in April 2003.

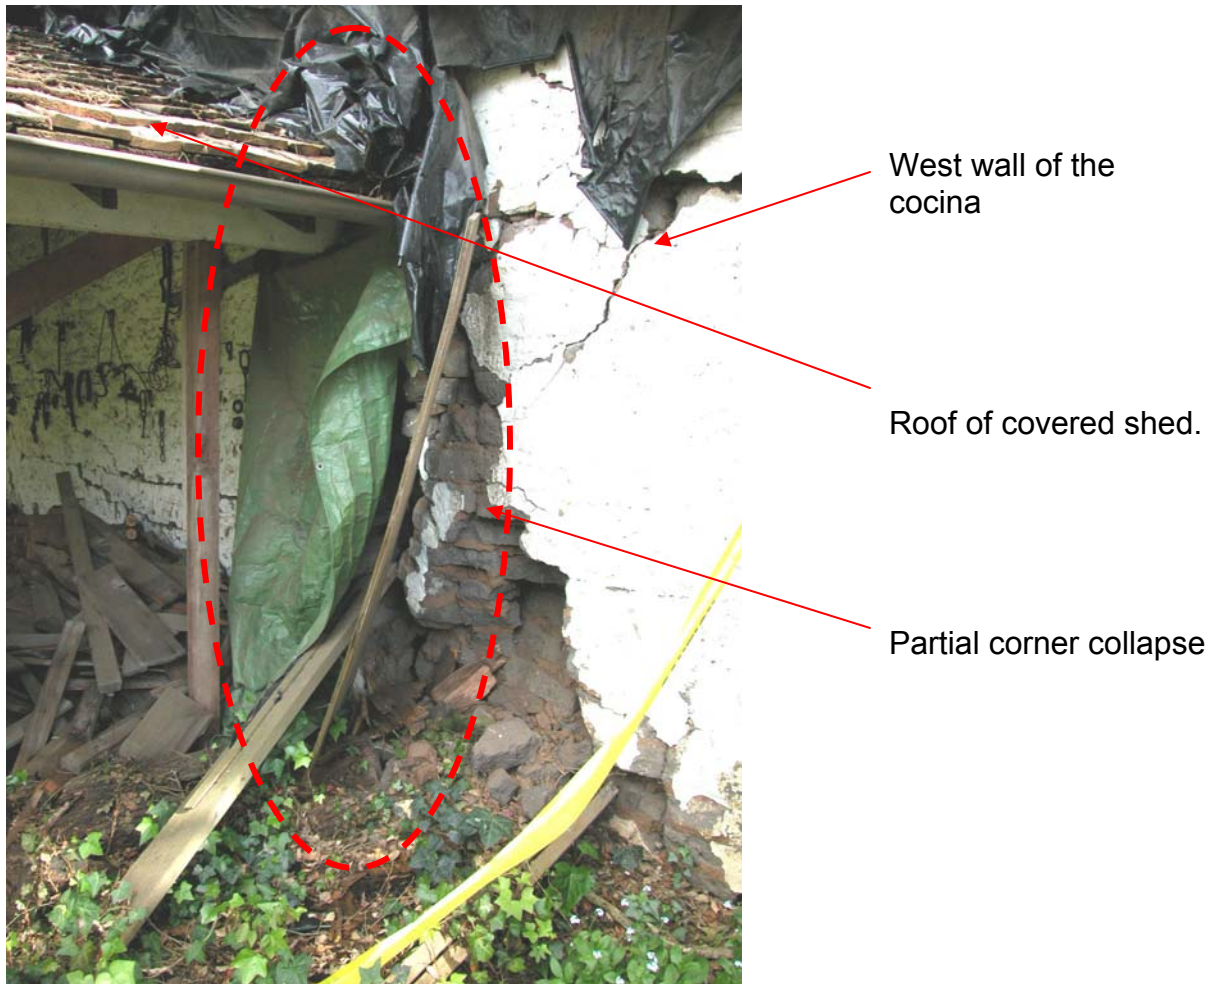
The north wall of the cocina was damaged extensively as well. Both the northeast and the northwest corners suffered numerous structural cracks and a section of the northwest corner collapsed. The northeast corner remained intact, but a small section of adobe masonry was also displaced. A long horizontal crack extends nearly the entire length of this north wall with increased displacement from the east end as it approaches the west end at the northwest corner. Figures 5.7 and 5.8 show some of the more severe damage to this wall.

**Figure 5.7:** The northwest corner of the cocina, Room 101, from the north west. Digital photograph by A. Crosby, April 2003.

- Reconstruct the northwest corner of the cocina, Room 101. The reconstruction is necessary because of the severe damage of this part of the structure. It will require the partial removal of a short section of the west wall immediate next to the corner as well as a short portion of the north wall.

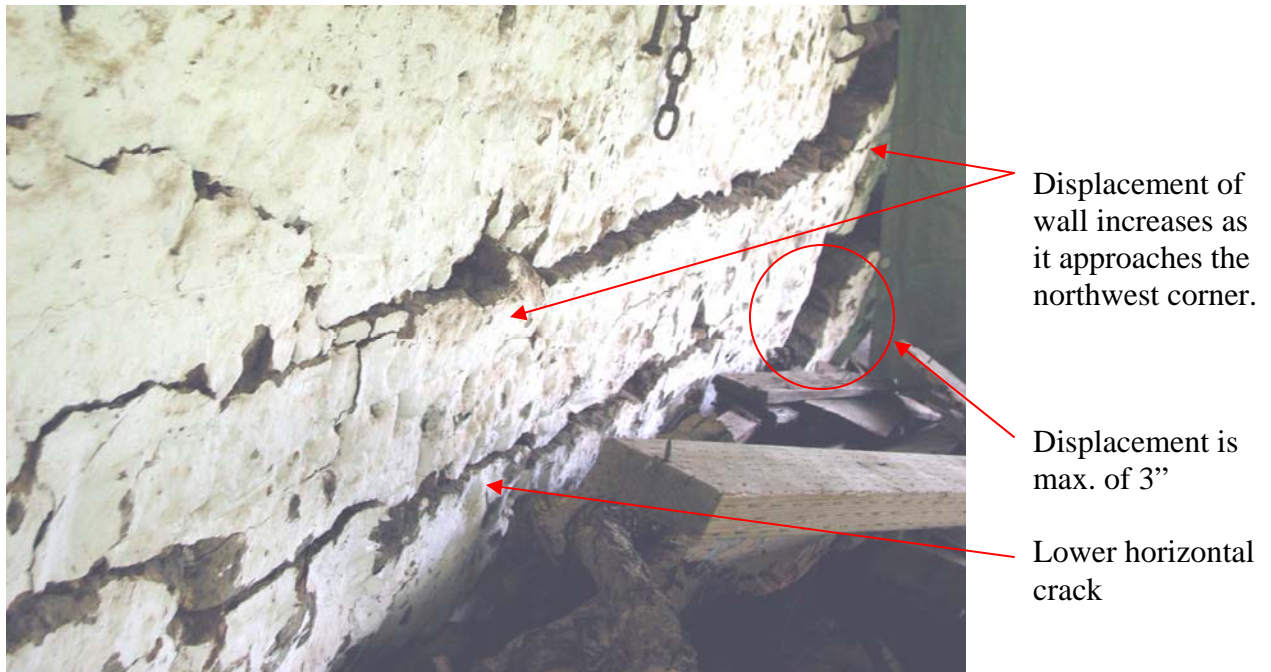
**Figure 5.8:** Detail of the north wall of the cocina looking toward the northwest corner showing displacement of the wall along the horizontal wall cracks. Digital photograph by A. Crosby, April 2003.

- Replace the lower part of the north wall. The lower part of this wall from the approximate centerline to the northwest corner has shifted horizontally away from the main wall plane. It may be possible to support the upper part of the wall above the horizontal crack and then move the shifted part back into place. Moving the shifted part back may cause additional damage to the remainder of the wall. Through-pinning the wall approximately every 3 feet can support the upper portion. The lower part can then be removed and then the replacement part constructed. Depending on the condition of the foundation a new partial foundation may be required. The lower several courses should be constructed of stabilized adobes.

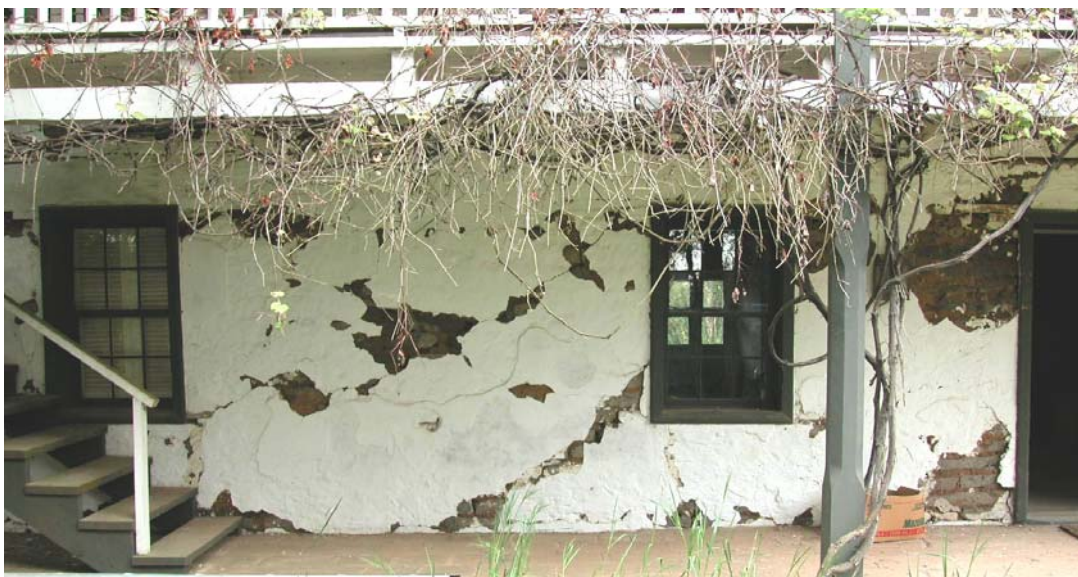
The 1989 earthquake resulted in numerous shear cracks in the east and west walls, but little significant displacement. Figure 5.9 is a typical section of the east wall showing some of the wall shear cracks.

**Figure 5.9:** A section of the east wall showing a series of diagonal shear cracks. Digital photograph by A. Crosby, April 2003.

- Repair the east and the west exterior adobe walls. These two long walls have been damaged by the earthquake, but not so severely that they cannot be repaired. Repair will consist of grouting with a compatible material with low pressure and minor stitching of some

of the more severe cracks. The stitching may not be necessary, but is dependent on the seismic design.

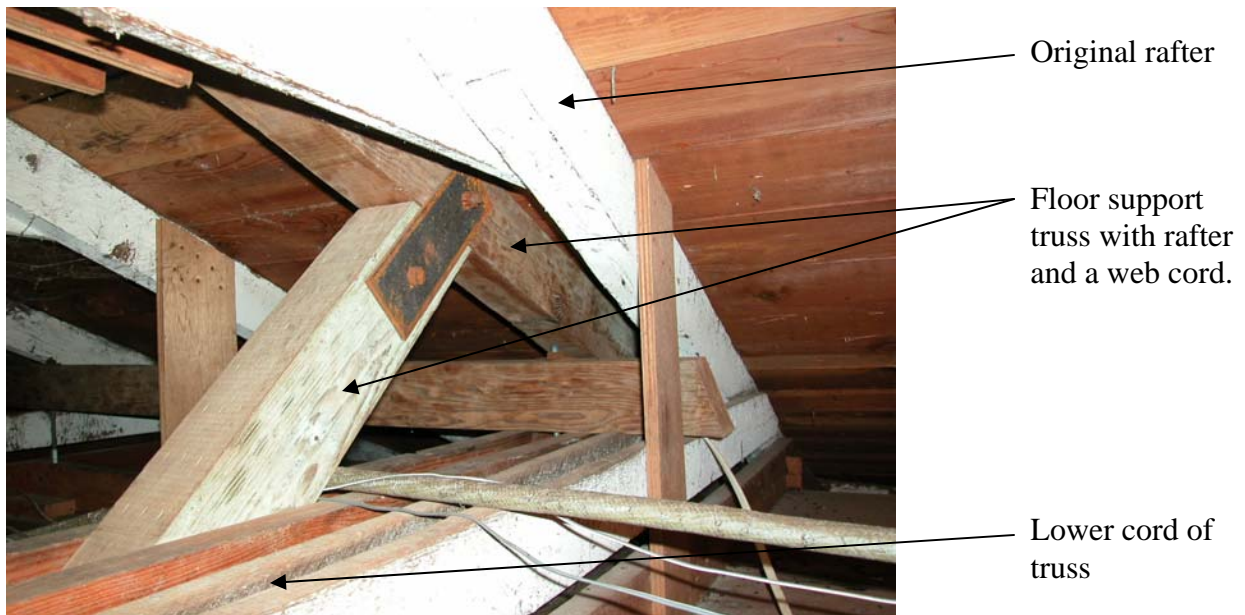
The modification to the roof to carry the load of the second floor via the steel support rods is a heavy timber truss. The steel rods are actually connected to a heavy timber plate that is supported by the lower cord of the truss. Diagonal web members are attached to the rafters by steel plates. Figure 5.11 is a photograph of a detail of the support system.

**Figure 5.11:** A detail of the roof system that supports the second floor. Digital photograph by A. Crosby, April 2003.

- As part of the retrofit engineering, undertake an engineering study of the roof system. It appears that at a minimum, the connections of the roof-framing members are suspect. In addition, the extent of termite damage must be analyzed to determine the possible loss of structural load carrying capacity in the roof members.

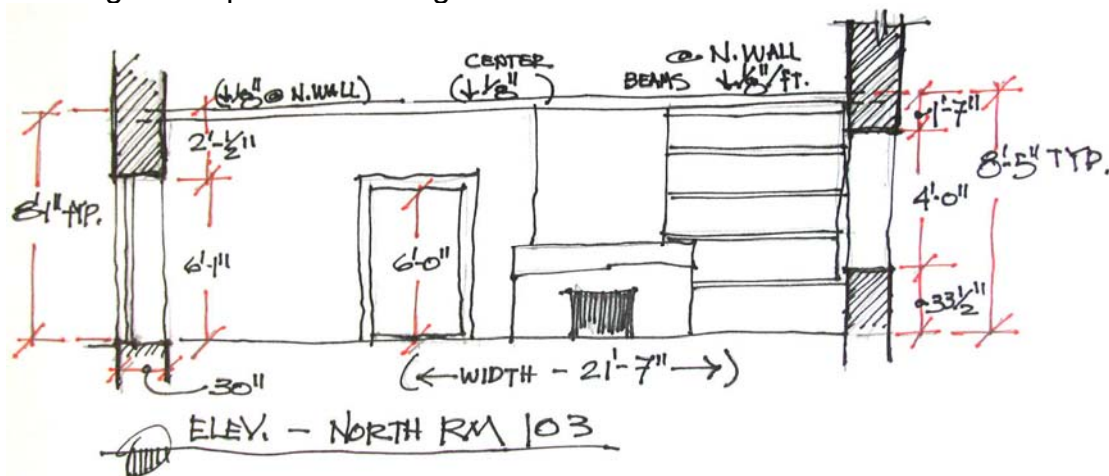
The first floor ceiling system of the structure appears to be original. Several replacement ceiling boards were identified, and others have been severely sand blasted. Others may have been reused, but they are relatively few. The dimensions of the ceiling boards and the joists vary somewhat. The ceiling and second floor is supported by beaded joists spanning the ceiling nearly 22 feet. The joists slope from west to east an average of 5 inches. Figure 5.12 is a sketch showing the slope of the ceiling and floor.

**Figure 5.12:** Field sketch of a section through Room 103 looking south showing the 4-5 inch slope from west to east.

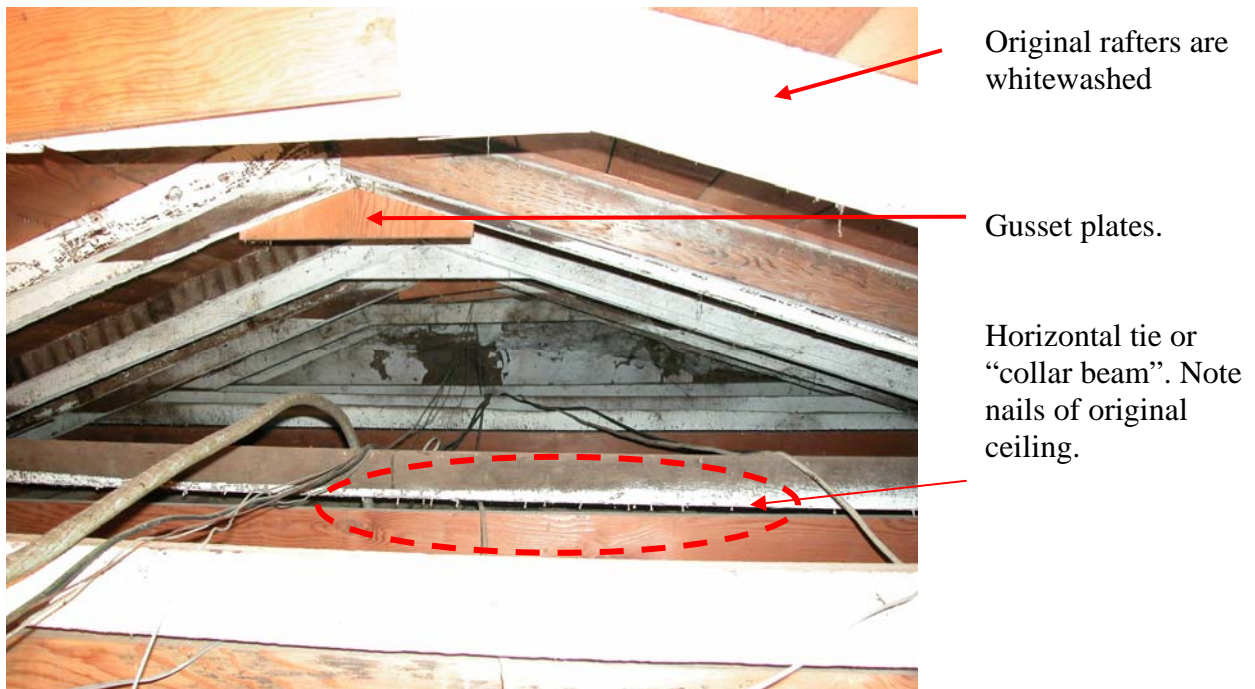
The second floor ceiling is a complete replacement, although many early boards were used, either from the earlier ceiling or from another structure. The original ceiling was attached to the underside of the roof rafters and then to horizontal cross members so that the upper part of the ceiling was flat. The present ceiling is also this same basic configuration, but the sloped portion is shorter as the ceiling boards do not extend as high on the rafters and the flat part, consequently is wider. Many of the original horizontal members remain in place to indicate the actual height of the original ceiling. The rafters and other roof and ceiling members were whitewashed after the original ceiling was removed. Figure 5.13 shows a view of the attic and the typical conditions.

**Figure 5.13:** Typical condition in the attic. Digital photograph by A. Crosby, April 2003.

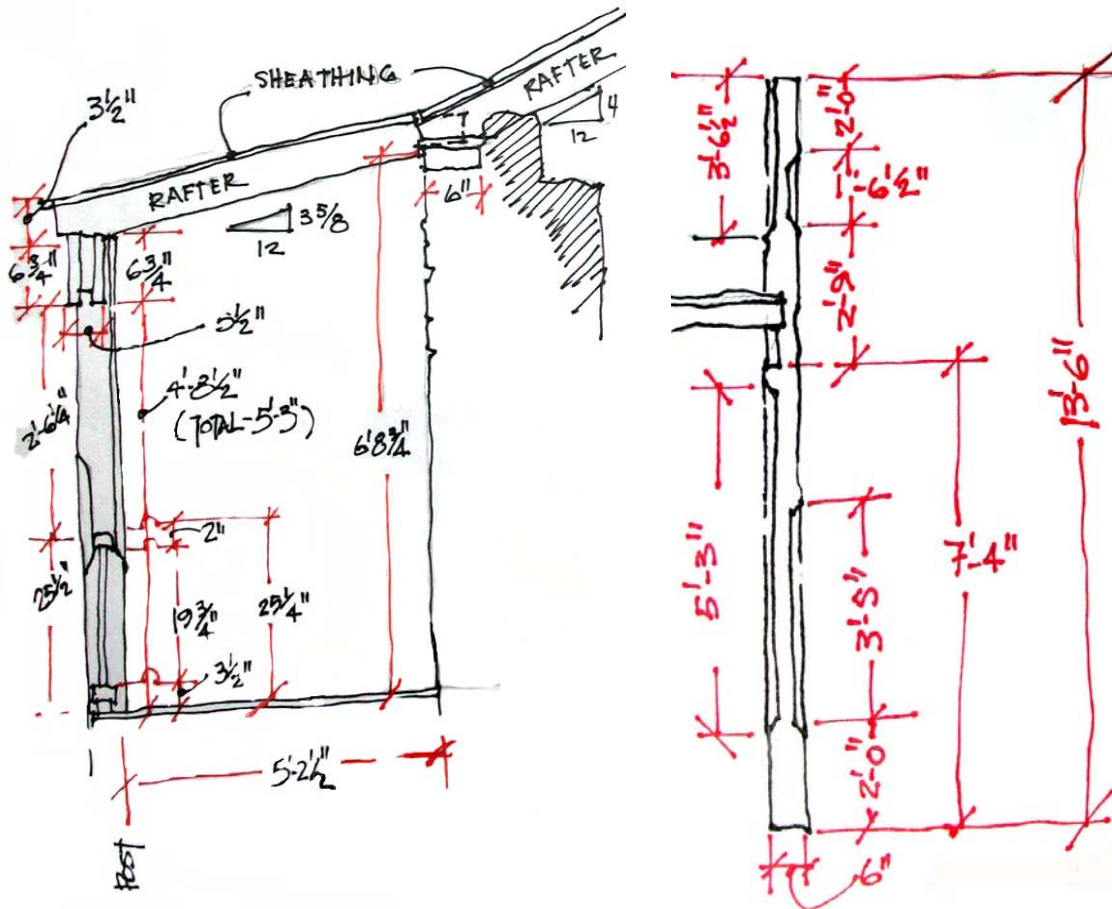
**Figure 5.15:** Field sketch of the east corredor and supporting posts.

The overall ceiling height at the adobe wall is 6'-8  $\frac{3}{4}$ ", but only 5'-3" to the underside of the rafter at the outer edge of the corredor. The lintel extends down another 6  $\frac{3}{4}$  inches to a clearance of only 4'-8  $\frac{1}{2}$ ". Not only does this present a safety problem, it also restricts the view from the second level balcony.

- Replace the east corredor posts and roof system. The roof system, the supporting posts, the balustrade and the lintel details are not appropriate. Alternatives are discussed in another part of this section. The posts were slightly larger and shaped differently than the current posts. Remnants may still exist in the east exterior wall of the cocina.
- Raise the existing corridor roof pitch and the west ends of the rafters for a higher clearance on the second floor.
- Replace the existing balustrade. The current one is far too short and is a safety hazard. The original balustrade was taller.
- Replace the west wall corridor posts. These posts are also incorrect and should be replaced with the same general design that will be used in the replacement of the east corridor posts. The existing rafter and later replacements should be retained in place and be part of the restoration.

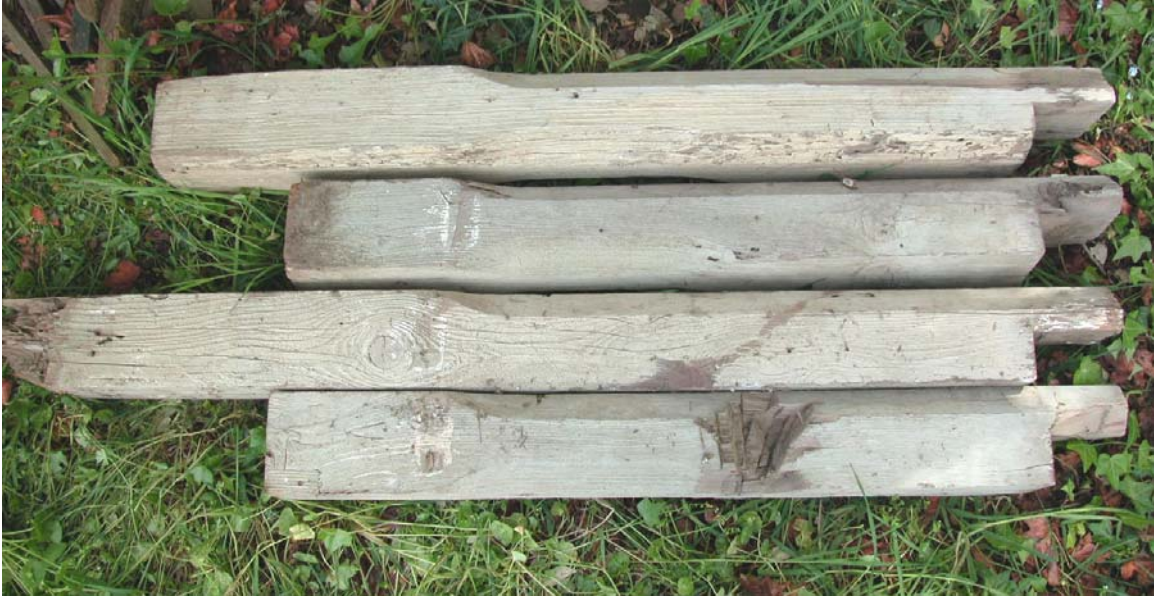
**Figure 5.16:** Corredor posts in the storage shed that previously existed on the east corredor. Digital photograph by A. Crosby, April 2003.

These four posts retain evidence of the east corredor balustrade and are consistent in size. The height is the same as that of the current posts and the balustrade is also the same. This indicated that the ca. 1900 alterations were accurately replicated in ca. 1960.

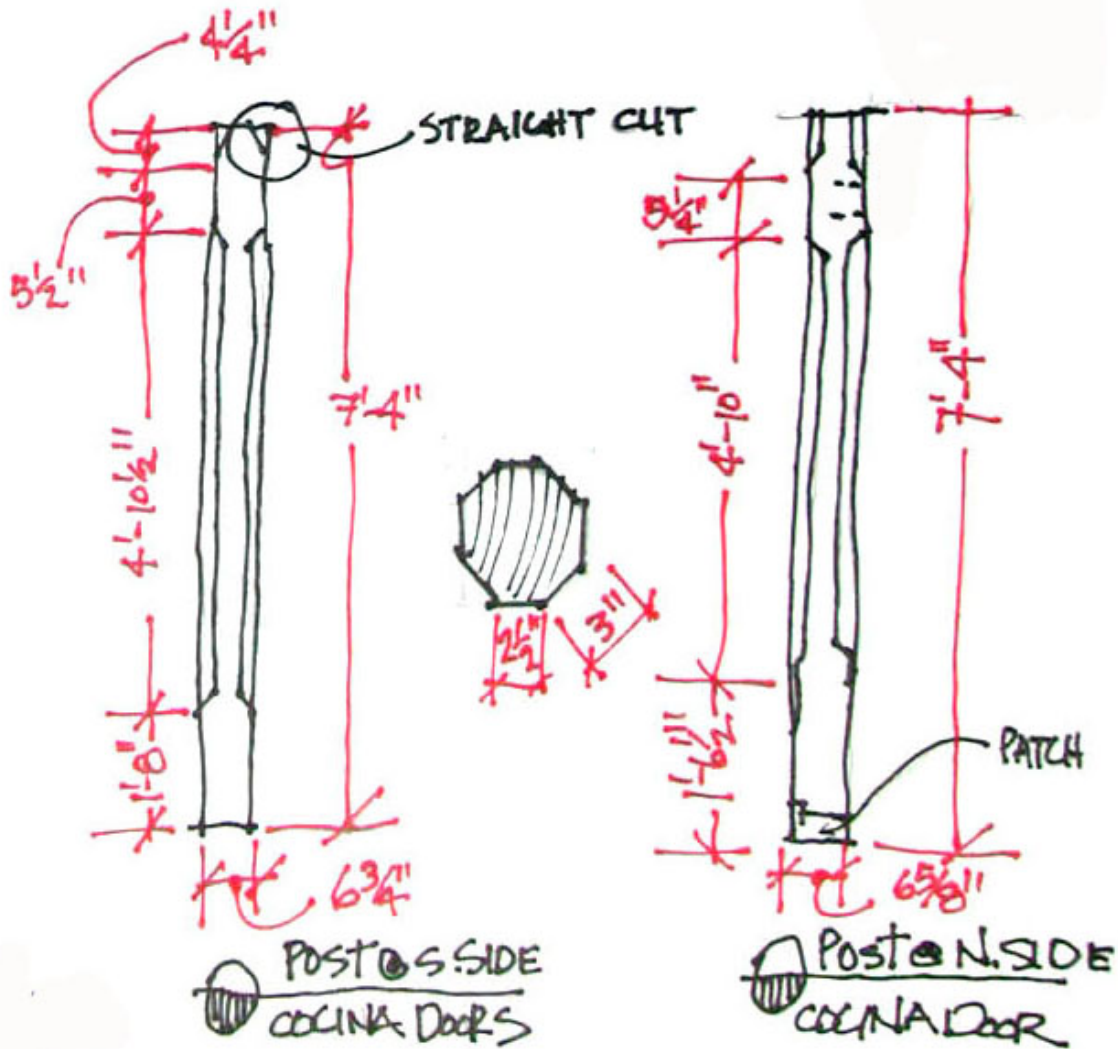
Of the four posts in the east wall of the cocina, two have the same details as the four posts in the shed and the current corredor posts. The two posts on either side of the cocina doors, however, are different and may well be the only remaining physical evidence of the original corredor posts. Figure 5.17 is a field sketch of several of the posts that were documented. They are slightly larger, 6  $\frac{3}{4}$  inches compared to the existing of 6 inches and are symmetrically chamfered. The height also seems appropriate for the east corredor posts. There is other evidence that that under closer investigation may clarify other questions of original details. The additional investigation will require the removal of the posts from the wall, which was beyond the scope of this effort.

**Figure 5.17:** Two posts in the east wall of the cocina that might be from the original corridor.
